Datum date	GEZ. draft	GEPR. check	NORM stand.	Ä-IND. ch.-ind.	ANZ. no.	ÄND./FR. change/rel.	ERS.F. exch. of	Dok-Nr. doc.no.	Dok-Vers. doc-vers.	ANLAGE = plant	ORT + HS location	 Winnenden	BENENNUNG identification	STROMLAUFPLAN WIRING DIAGRAM	ZEICHNUNGS-NR. drawing-no.		
13.05.03	HFR	WSB	CST-D	C	1	2005887	01.04.03	001	03	AUFTRAG order no.	0.088-550		ANLAG.-BEZ. plant desig.	0.088-550	BLATT page	1	BLATTZ. page tot.
File: HD-1025-V7							 Dokument document		5032950

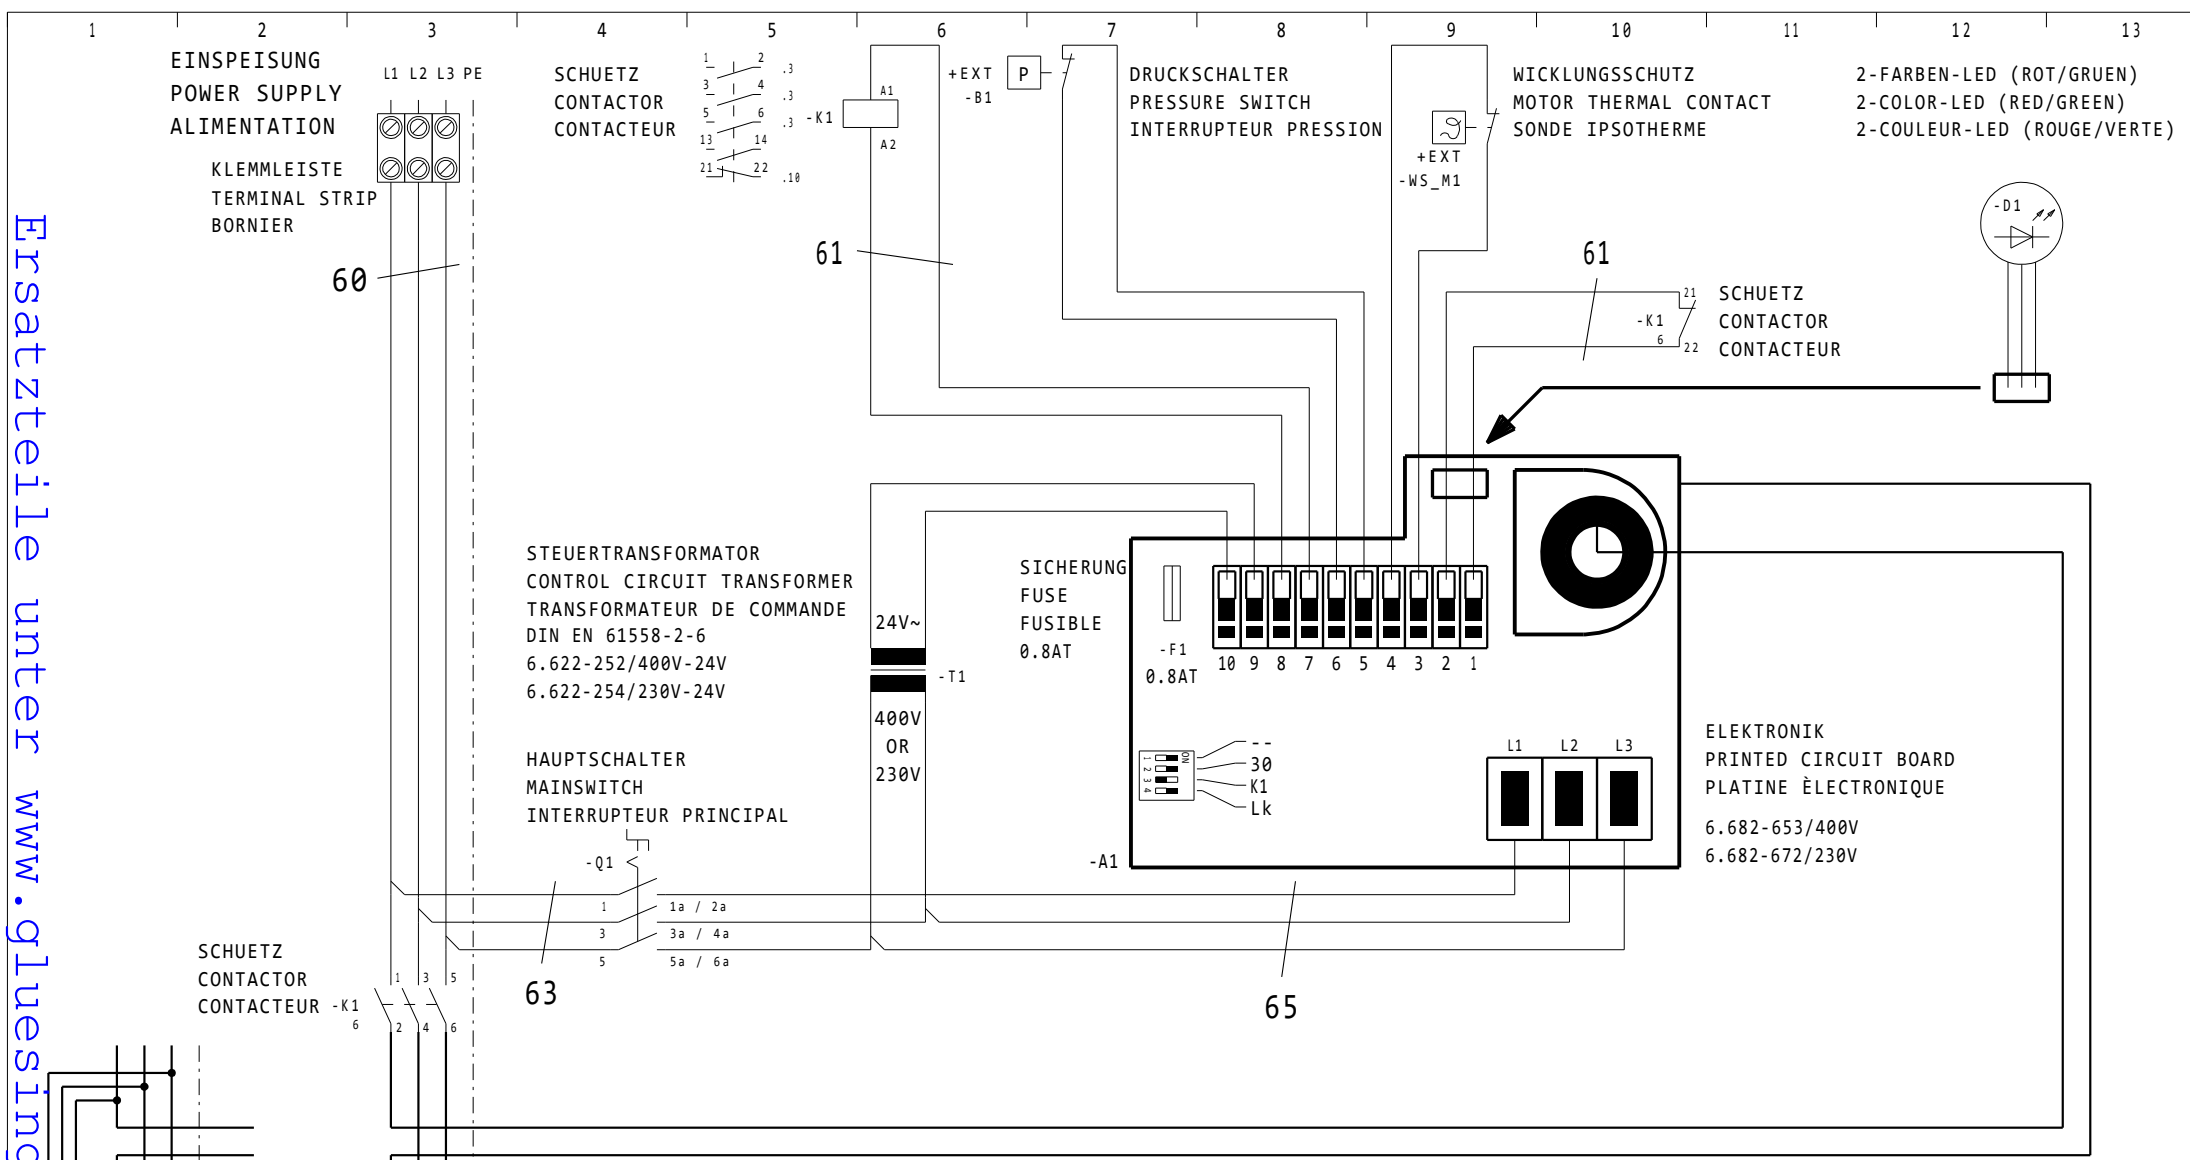
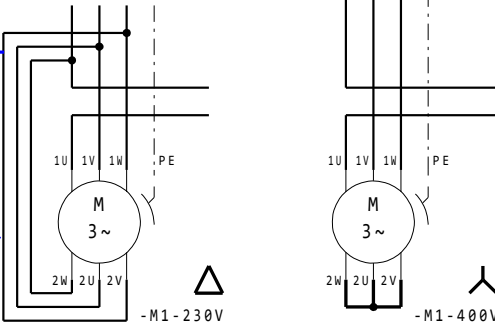
OFF ON	-- NICHT BELEGT 30 30 MINUTEN DAUERBETRIEB / DAURPAUSE K1 SCHUETZUEBERPRUEFUNG Lk LECKAGEUEBERWACHUNG	-- NOT IN USE 30 30 MINUTES PERMANENT OPERATION/PERMANENT BREAK K1 CONTACTOR MONITORING Lk LEAKAGE MONITORING	-- LIBRE 30 FONCTIONNMENT EN CONTINU PENDANT 30 MINUTES/PAUSE PERMANETE K1 CONTRÔLE DU FONCTIONNEMENT DU CONTACTEUR Lk SURVEILLANCE DES FUITES
------------	--	--	---
